Resin infiltration for the aesthetic management of mild molar-incisor hypomineralisation: a clinical case report

Dr Federico Emiliani

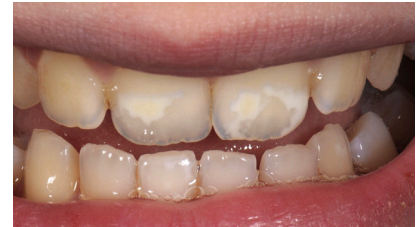
A 10-year-old female patient presented with mild molar-incisor hypomineralisation (MIH) involving the permanent first molars and the maxillary central incisors. The patient's parents expressed a specific aesthetic concern regarding the visible enamel opacities on the upper incisors (Fig. 1).

Fig. 1: Extraoral view of the lesions on the two maxillary incisors

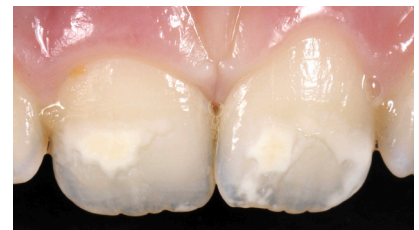
Intraoral examination revealed demarcated hypomineralised areas on teeth 1.1 and 2.1, with an irregular distribution and heterogeneous opacity (Fig. 2). No cavitation or post-eruptive enamel breakdown was detected.

Fig. 2: Intraoral view of the enamel defects

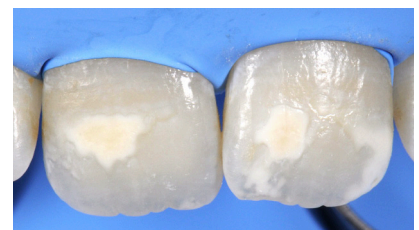
Fig. 4: Isolation of the operative field using a rubber dam

The operative field was isolated using a rubber dam to ensure moisture control, improve visibility and provide a safe working environment during repeated erosive and infiltration steps (Fig. 4). The isolation also allowed a conservative and controlled approach while monitoring enamel changes at each stage.

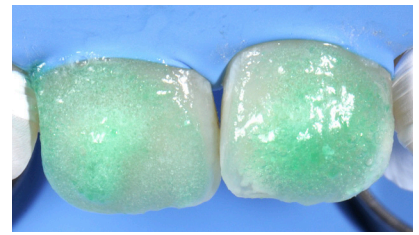
Fig. 5: Application of Icon Etch (HCl 15%)

A 15% hydrochloric acid gel (Icon Etch, DMG) was applied on the buccal surfaces of both maxillary central incisors for 2 minutes (Fig. 5). The gel was then thoroughly rinsed and the surface was evaluated.

Clinical rationale: MIH-related opacities often present a hypermineralised superficial layer that limits resin penetration. Controlled chemical erosion is used to remove this layer and expose the porous lesion body, improving the masking effect after infiltration¹⁷.

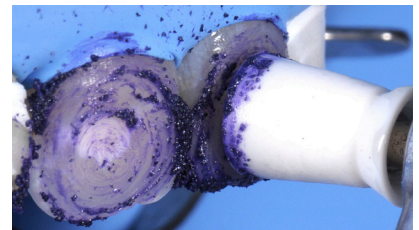
Fig. 7: Microabrasion with Opal Cup (Ultradent) + Opalustre

After the initial etching step, microabrasion was performed using a hydrochloric acid-based microabrasion paste (Opalustre, Ultradent; HCl 6.6%) (Fig. 6). The paste was activated with a dedicated rubber cup (OpalCup, Ultradent) for 1 minute per tooth (Fig. 7).

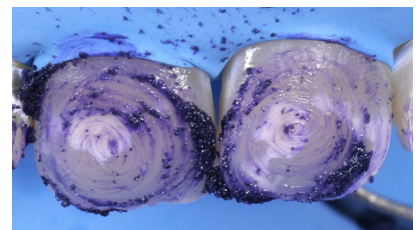
Fig. 8: Frontal view of the action of Opalustre

A frontal view during microabrasion illustrates the clinical action of the paste and the controlled removal of superficial enamel (Fig. 8).

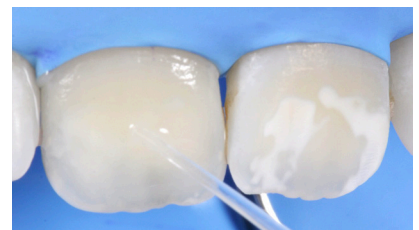
Fig. 9: Appearance of the lesion on tooth 1.1 after application of Icon Dry – the lesion disappeared

On tooth 1.1, the lesion disappeared after ethanol application, indicating that the porous lesion body had been sufficiently exposed and that resin infiltration was likely to provide an effective masking result (Fig. 9).

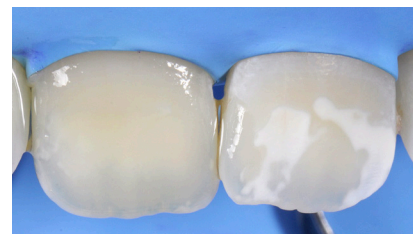
Fig. 12: Appearance of the lesion on tooth 1.1 after infiltration, prior to light curing and removal of excess material

The infiltrant resin (Icon Infiltrant, DMG) was applied to tooth 1.1 and left in contact for 3 minutes (Fig. 11). The resin was allowed to penetrate the lesion by capillary action. The surface appearance after infiltration – before light curing and excess removal—is shown in Fig. 12.

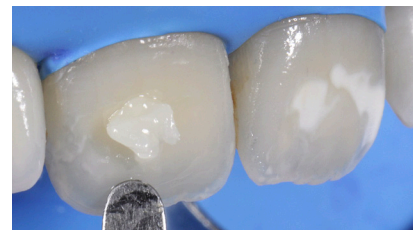
Fig. 13: Application of a thin layer of composite is required to compensate for the minor loss of tissue. The composite used was Ecosite Elements Pure A1 (DMG)

A nanohybrid composite (Ecosite Element, DMG, shade A1) was placed directly over the infiltrated surface after light curing of the infiltrant (Fig. 13). No additional adhesive procedure was performed. The composite was then light-cured.

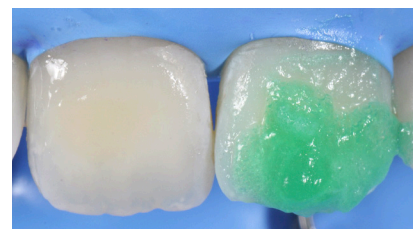
Fig. 14: Two additional applications of Icon Etch on tooth 2.1

At this stage, tooth 1.1 was completed (pre-polishing view, Fig. 14). Considering the incomplete masking during the ethanol test on tooth 2.1 (Fig. 10), an additional 2 minute etching cycle with Icon Etch was performed on 2.1 (Fig. 14).

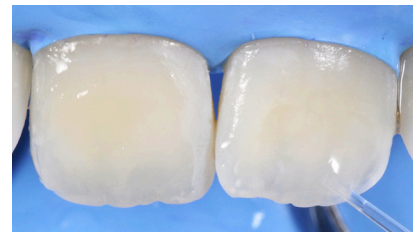
Fig. 15: Result achieved on tooth 2.1 after applying Icon Dry is satisfactory – the lesion is no longer visible

After this additional surface-layer removal, the ethanol test (Icon Dry) produced a favourable result: the lesion was no longer visible, indicating that infiltration could be expected to successfully mask the defect (Fig. 15). The clinical appearance of tooth 2.1 before infiltration is shown in Fig. 16.

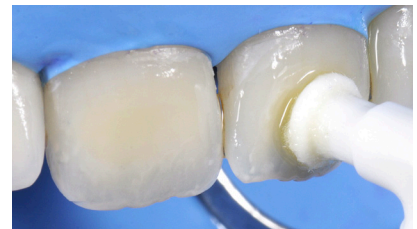
Fig. 17: Resin infiltration on tooth 2.1

Icon Infiltrant (DMG) was applied on tooth 2.1 for 3 minutes (Fig. 17) and then light-cured. As performed for tooth 1.1, a minimal composite layer (Ecosite Element, DMG, A1) was placed directly on the infiltrated surface after curing (Fig. 18), in order to optimise surface integrity and finishing potential.

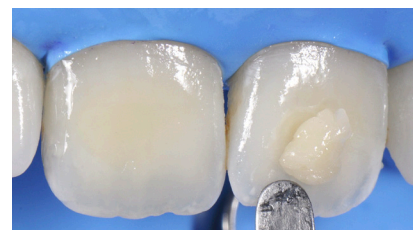
Fig. 18: After polymerisation of Icon Infiltrant, composite (Ecosite Elements Pure A1, DMG) is applied on the surface of tooth 2.1, directly over the infiltrated surface

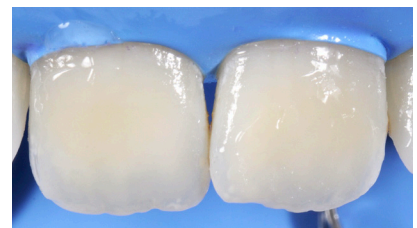
Fig. 19: Final result prior to surface finishing

The final result before surface finishing is shown in Fig. 19. A final light-curing cycle was performed under a transparent glycerine gel for 60 seconds (Fig. 20) to prevent oxygen inhibition at the composite surface and support complete polymerisation.

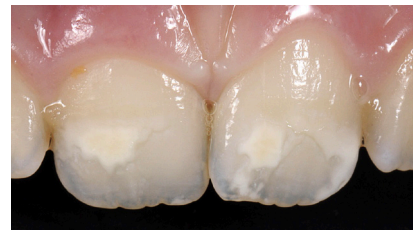
Fig. 23: Before-and-after comparison

A direct comparison between pre- and post-treatment images highlights the conservative nature of the approach and the effective masking of the MIH-related opacities, without signs of surface alteration or over-treatment – the original tooth anatomy is fully preserved and the treated surfaces are perfectly integrated (Fig. 23). The final extraoral view confirms a natural and harmonious smile appearance, fully addressing the initial aesthetic concern expressed by the patient's parents (Fig. 24).

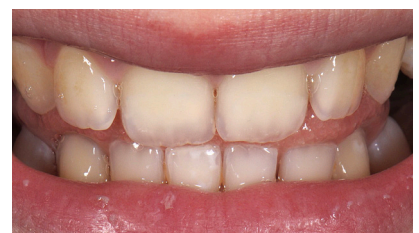
Fig. 24: Final smile, extraoral image
